DS-10-AF-KR MicroMini Marker

Dismantling And Repair Procedure

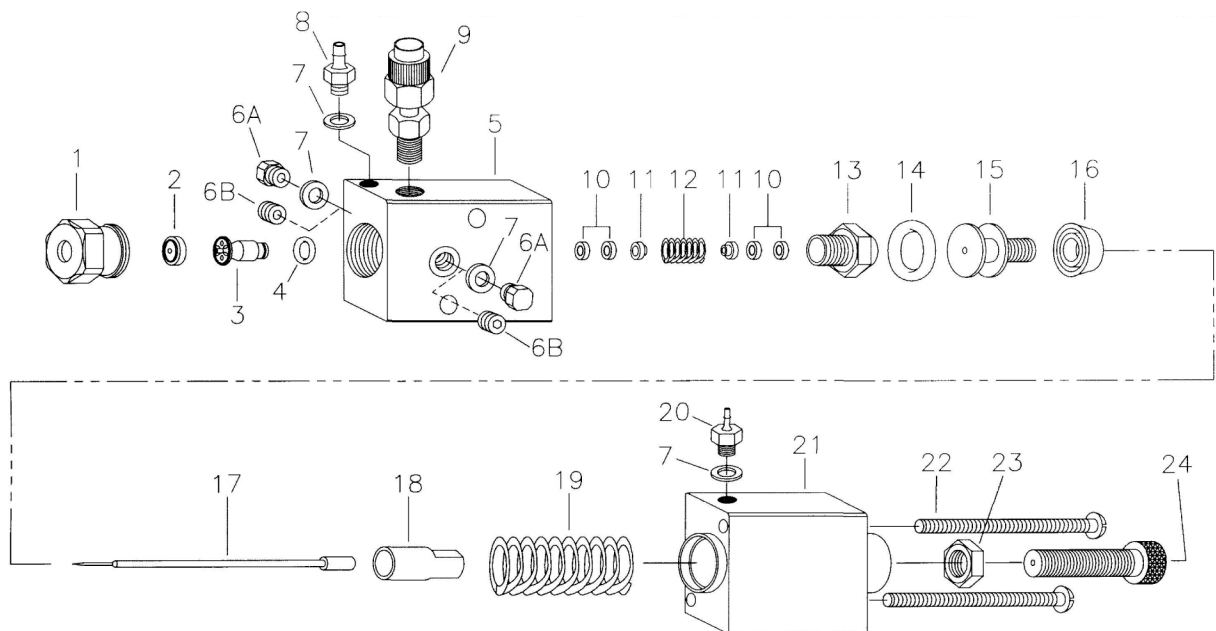
3. Remove Power Chamber #21 (using flat head screwdriver).
Remove the Shut-Off Spring #19 from inside the power Chamber.
4. Carefully remove Piston/Needle Assembly by pulling straight out from the opened back-end of the Packing Screw #13.

5. Remove Hex Retainer #1 (using a 9/16" wrench) from the front of the marker.
6. Remove Fluid Nozzle #3 and Air Cap #2, clean and set aside for re-assembly.

7. Remove the Fluid Nozzle "O" Ring #4, discard and replace.
8. Check Marker Body #5 for: (a) Ink build-up in Fluid Chamber. (b) Presence of ink in Packing Chamber. This can be determined by the presence of ink in the Power Chamber #21 or at the Bleeder Hole.

10. If ink is present in Packing Chamber, rebuild marker using Dell Marking Systems' 1018 Repair Kit. (a) Slowly remove Packing Screw #13 (using 3/8" nut driver). Packing spring is compressed. (b) Remove two Packing Glands #11 and set aside for re-assembly. Discard and replace Packing Spring #12 and four Teflon Packings #10.

11. If ink is present in Power Chamber #21, clean chamber with Dell Marking Systems' recommended clean-up solvent and replace "O" Ring #14 and Piston Seal #16.
